– *BELL POND DAM* –

VISUAL INSPECTION REPORT

Date of Inspection: September 27, 2016

April 11, 2017
GZA File No. 05.0045906.00

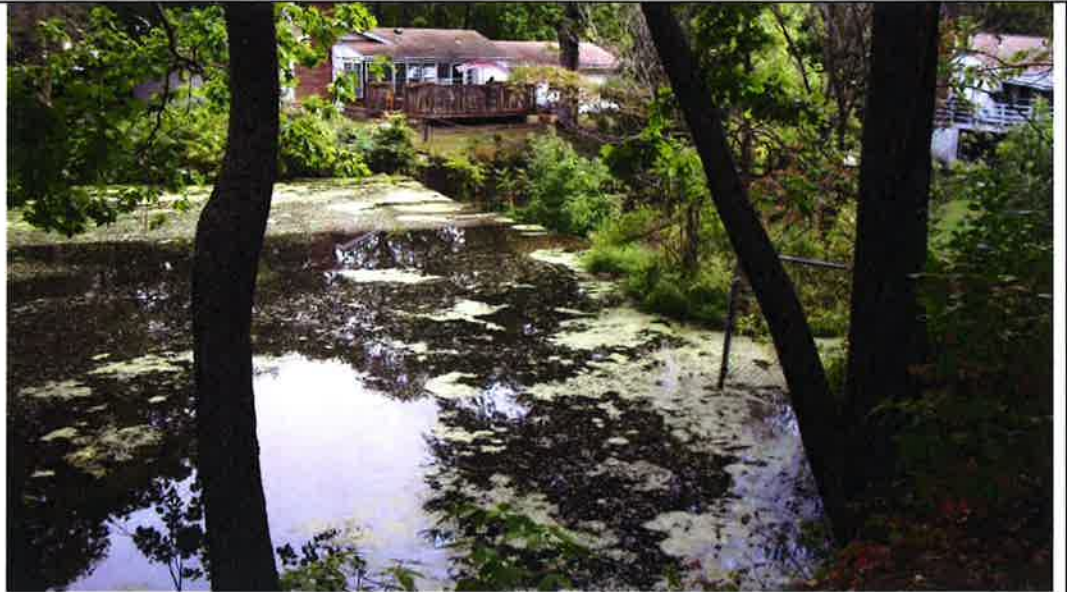
Photo No.: 01	Date: 9/27/16
Direction Photo Taken: Easterly	
Photographer: D. Barstow	
Description: Overview of dam from upstream.

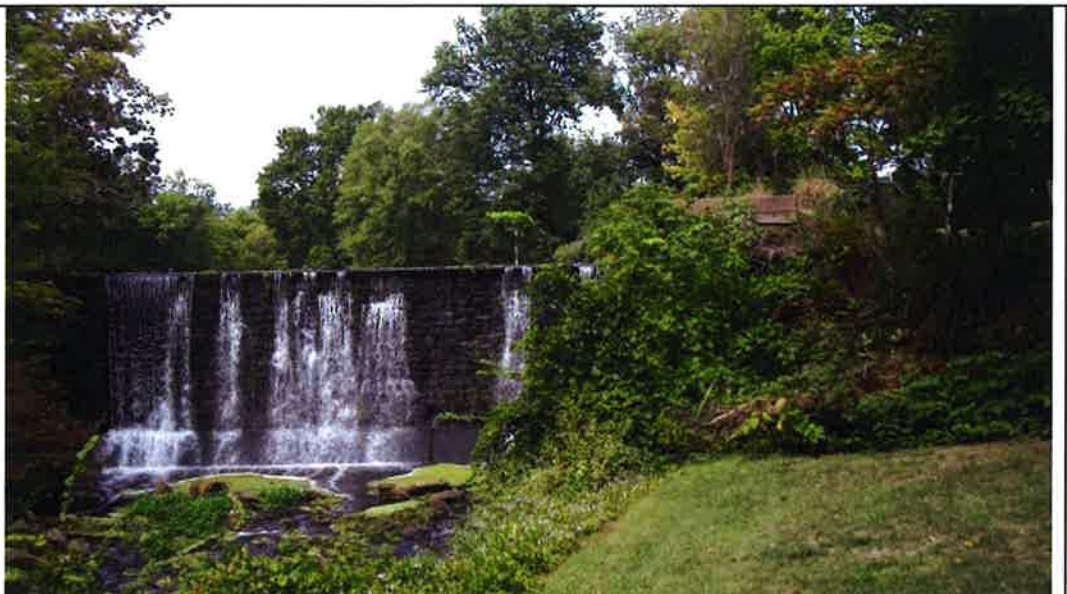
Photo No.: 02	Date: 9/27/16
Direction Photo Taken: Northwesterly	
Photographer: D. Barstow	
Description: Overview of dam from downstream.

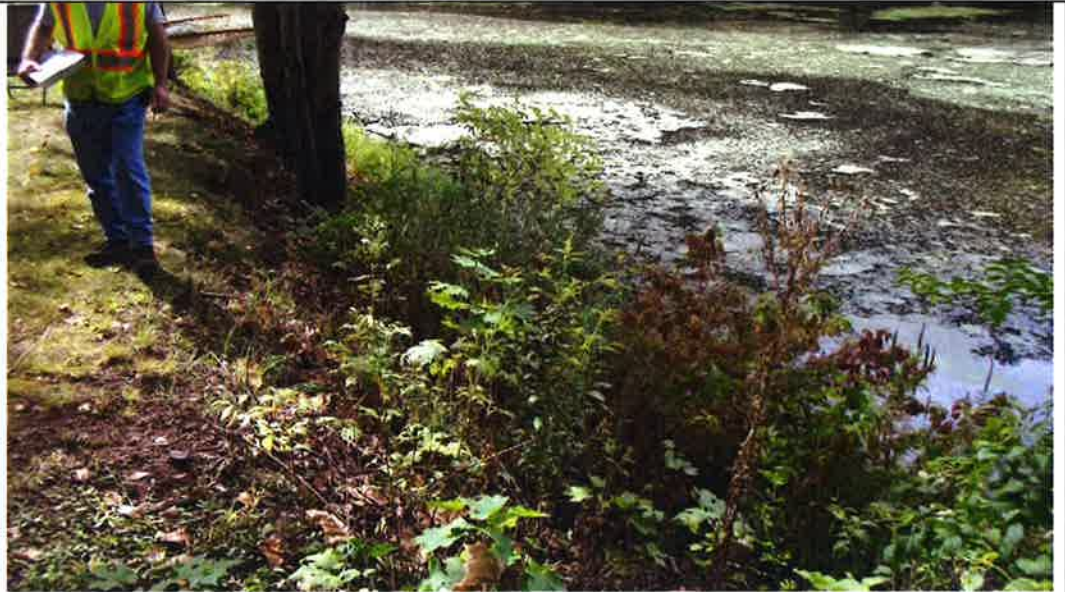
Photo No.: 03	Date: 9/27/16
Direction Photo Taken: Southerly	
Photographer: D. Barstow	
Description: Overview of upstream slope from left abutment. Note: mature trees and low brush on upstream slope of dike.

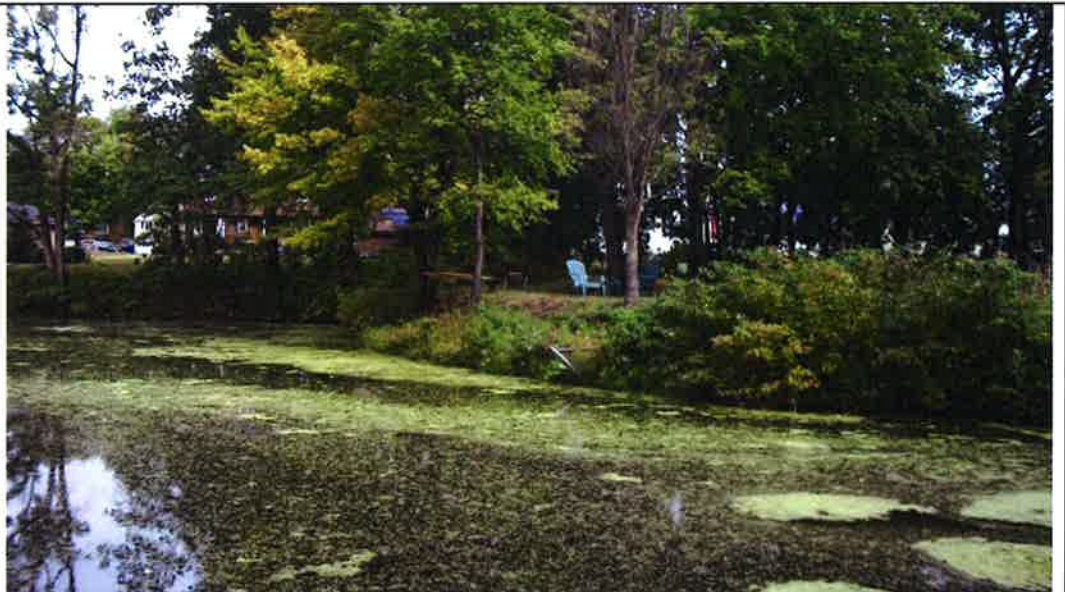
Vegetative Cover: The downstream (southern) portion of the upstream slope is covered with dense brush and vegetation. Additionally, several mature trees (up to 12-inch diameter), brush and oversteep areas with bare soils were observed on the upstream slope. The crest and the downstream slope are maintained grass (lawn). An 18- to 24-inch-diameter stump and roots system was observed at the right contact near the former turbine housing structure.

Photo No.: 04	Date: 9/27/16
Direction Photo Taken: Northeasterly	
Photographer: D. Barstow	
Description: Overview of dike. Note mature trees and brush on embankment

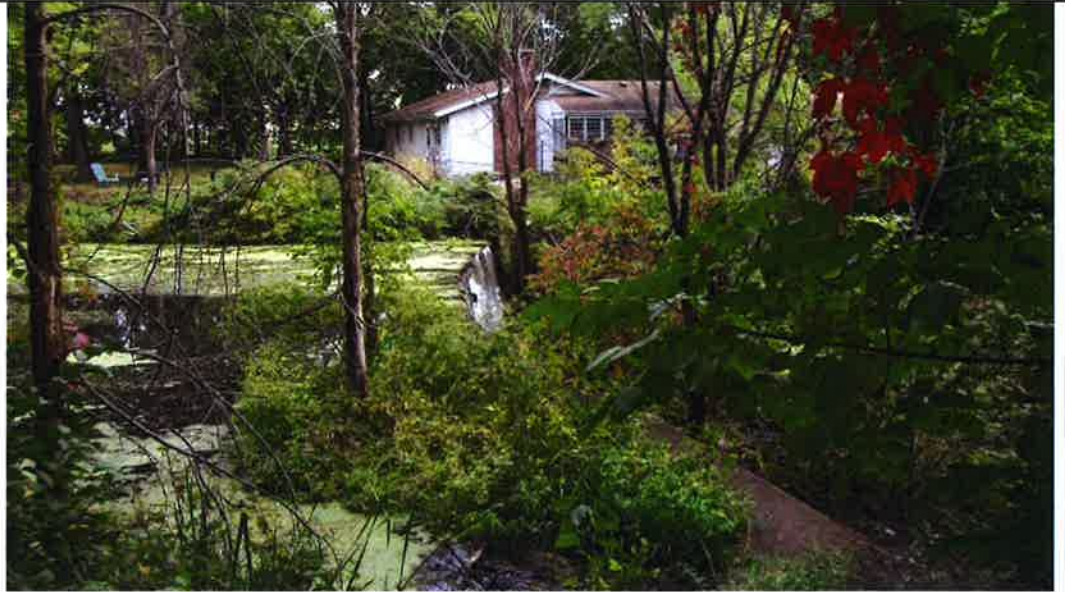
Description:
Overview of the auxiliary and primary spillway crests from right abutment.

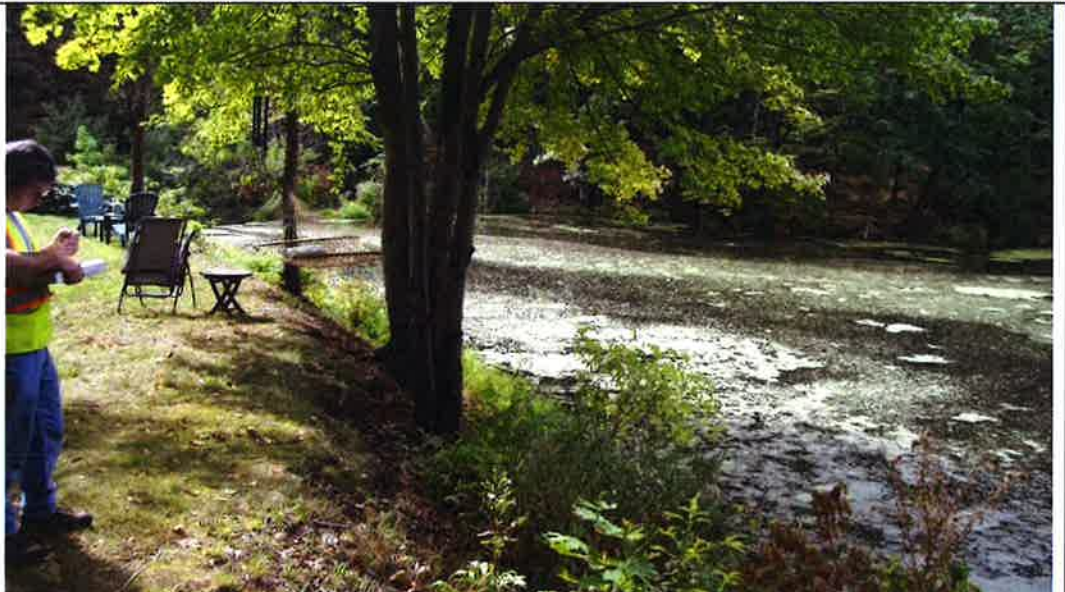
Description:
Overview of dike crest from left abutment.

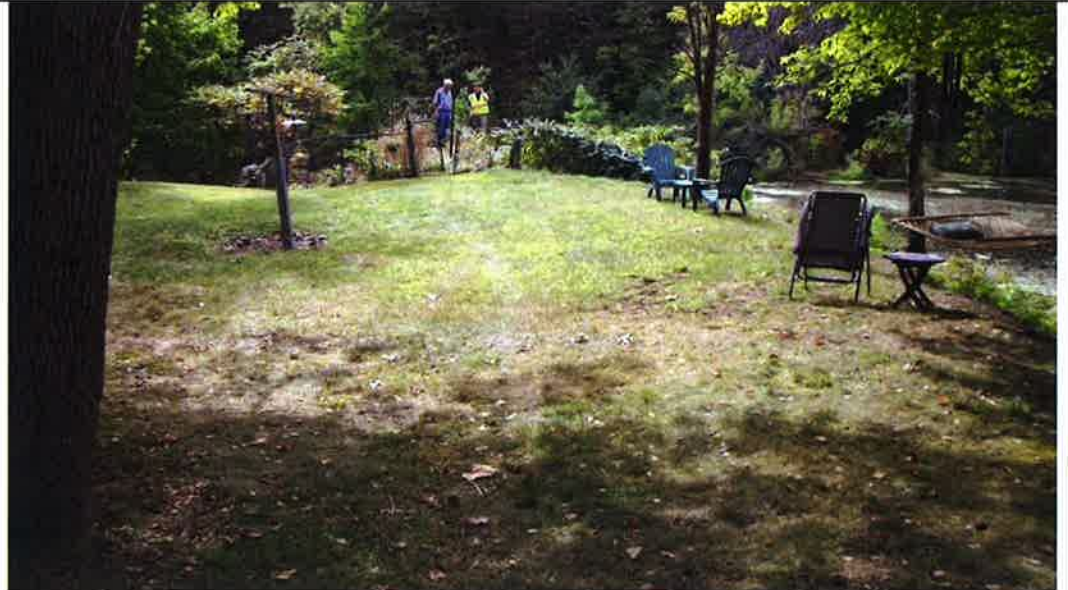
Overview of downstream face and crest of the dike from left abutment.

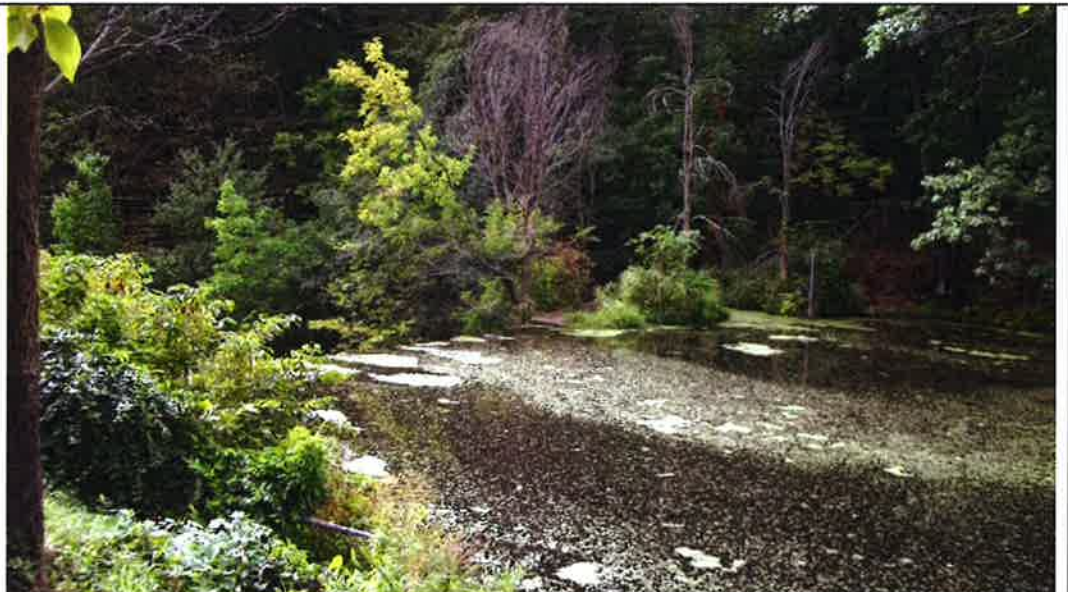
Vegetative Cover: Grassy vegetation and two, 3- to 6-inch diameter, dead trees were observed growing along the upstream side of the concrete cap. Several 3- to 8-inch diameter trees and dense brush were observed growing at the contact between the training wall and the mass concrete. A 4- to 6-inch diameter tree and brush were observed to be growing from the stone masonry face at the training wall and auxiliary spillway contact. This vegetation significantly limited visual observation.

Overview of spillway from upstream on the dike. Note trees and brush on right side of dam where the auxiliary spillway is located.

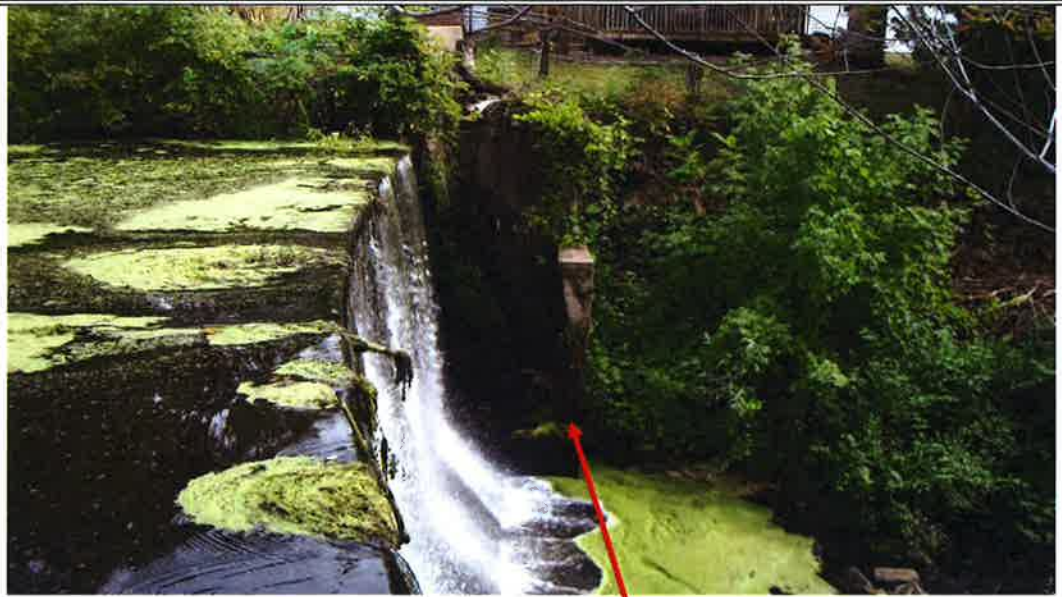
Former turbine housing structure

Primary spillway and former turbine housing structure.

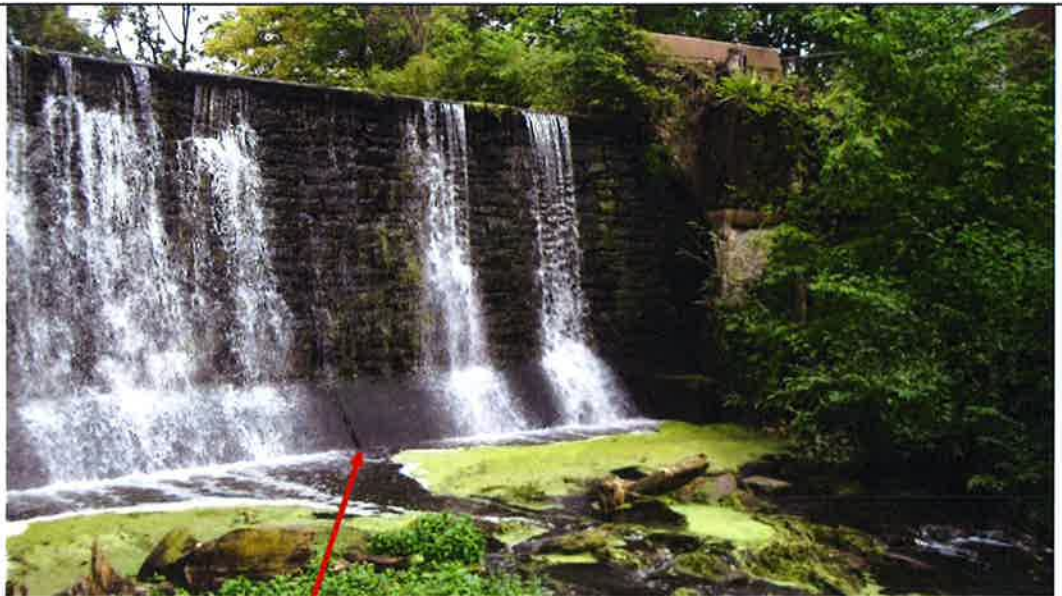
Misalignment of splash apron

Overview of spillway from downstream. Note misaligned splash apron in the center of the photo.

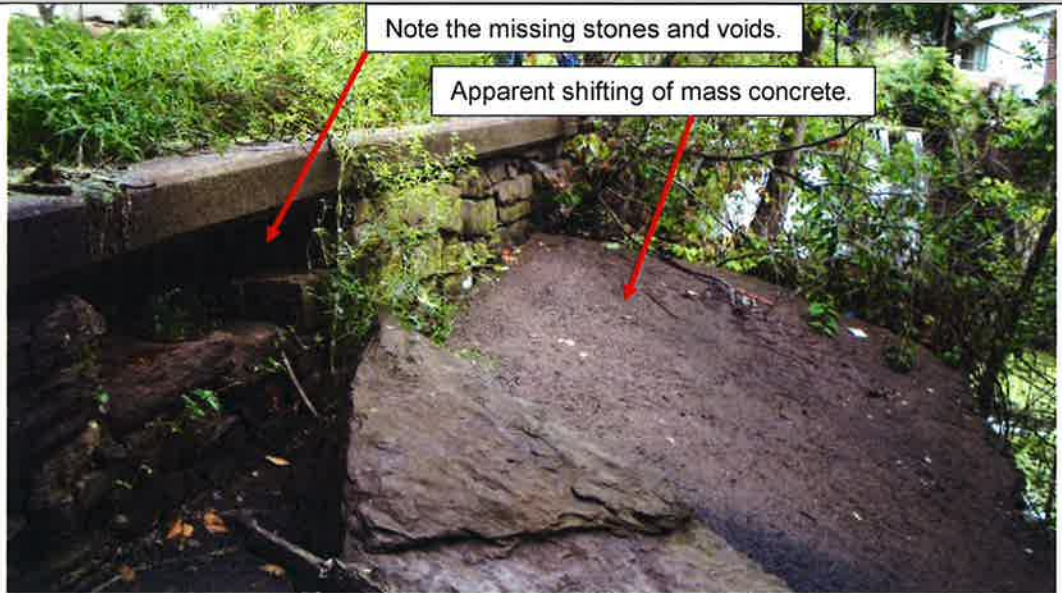
Stone Masonry: Poor – Missing face stone and gaps.

Scouring/Undermining: The concrete mass is undermined and water was observed seeping from below/around the concrete mass downstream of the dam.

Overview of auxiliary spillway from downstream. Note missing masonry blocks below the cap and large mass concrete pad (right side) that was poured for a repair.

- h. Perform an alternatives analysis of repair options for the dam including dam removal. Repairs will likely include the following:
 - i. Repair/replacement of deficient stone masonry and concrete.

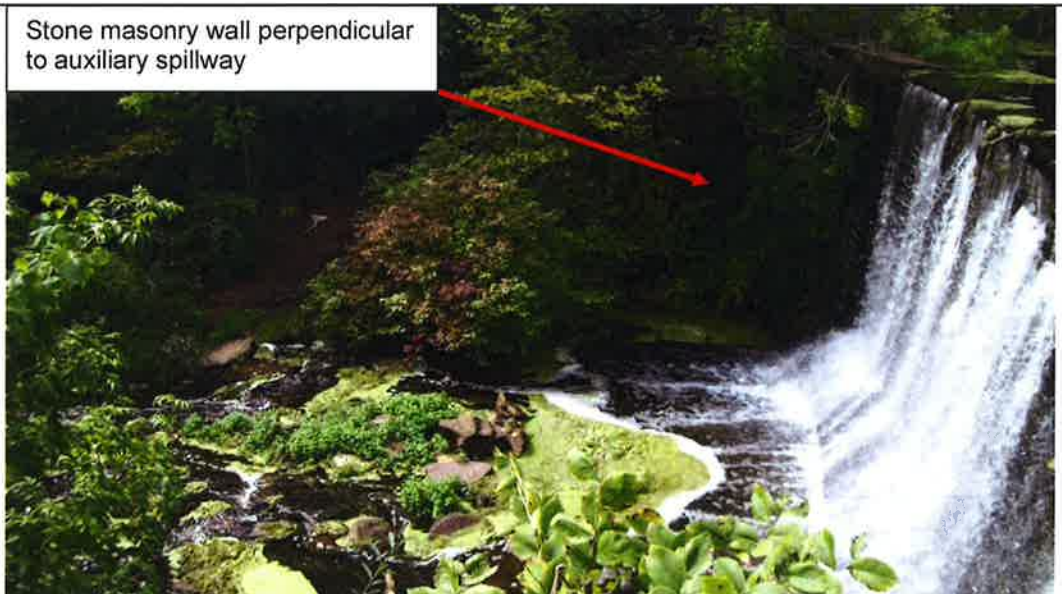
Riprap: Up to 24-inch diameter riprap / river stone was observed in the downstream channel. The downstream channel of the auxiliary spillway consists of siltstone bedrock.

Overview of downstream channel. Note large riprap in downstream channel.

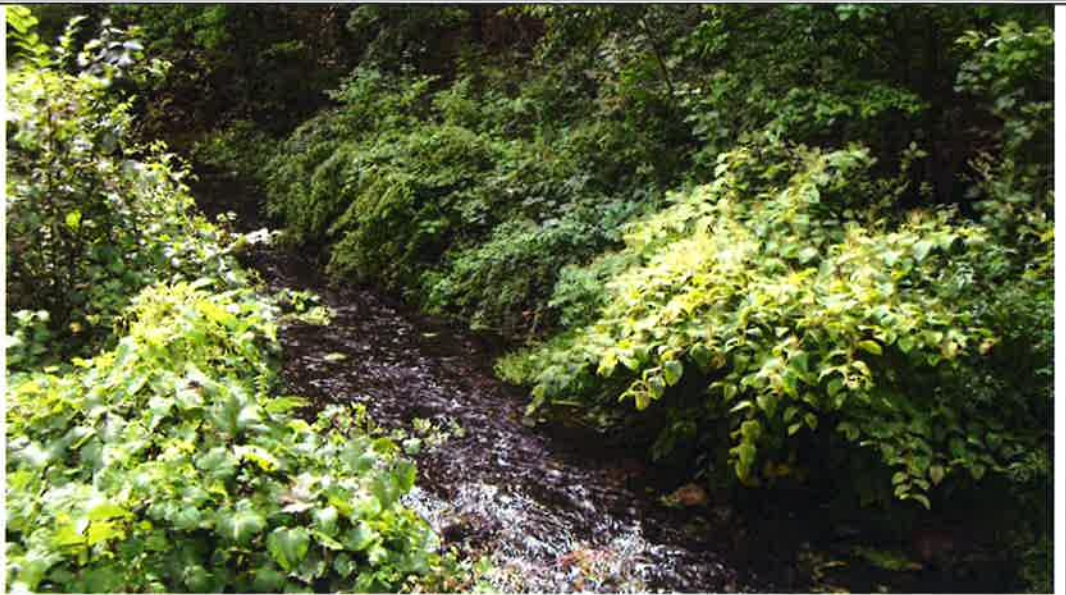
Description:
Overview of downstream channel.

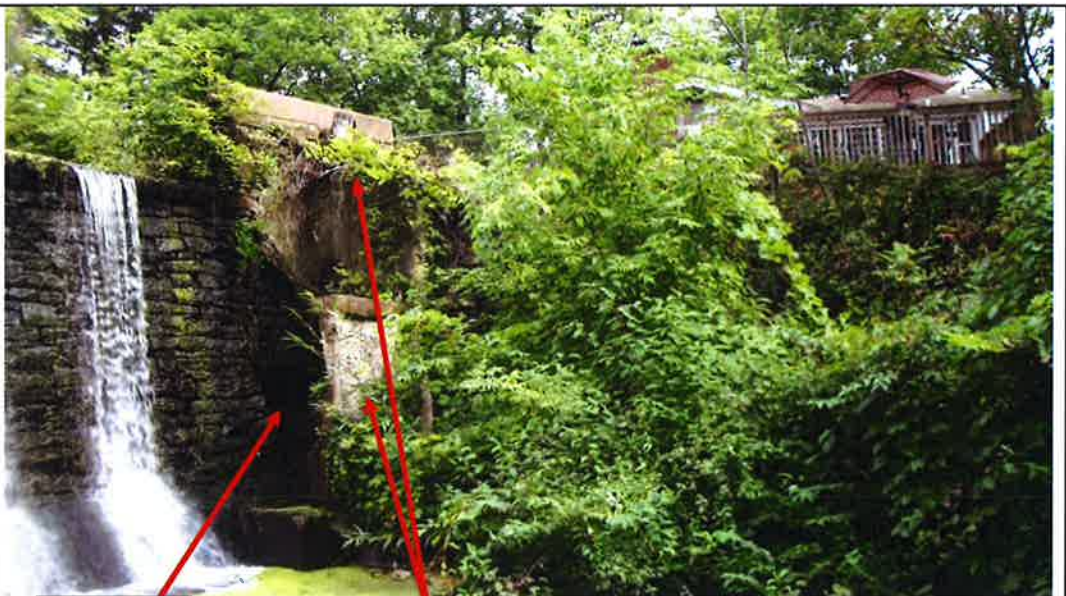
Former turbine housing structure

Concrete Condition: Poor – The concrete walls were observed to be cracked and spalled.

Description:
Overview of area where the former turbine housing structure was located. Note: the discharge location and spalling on concrete walls.

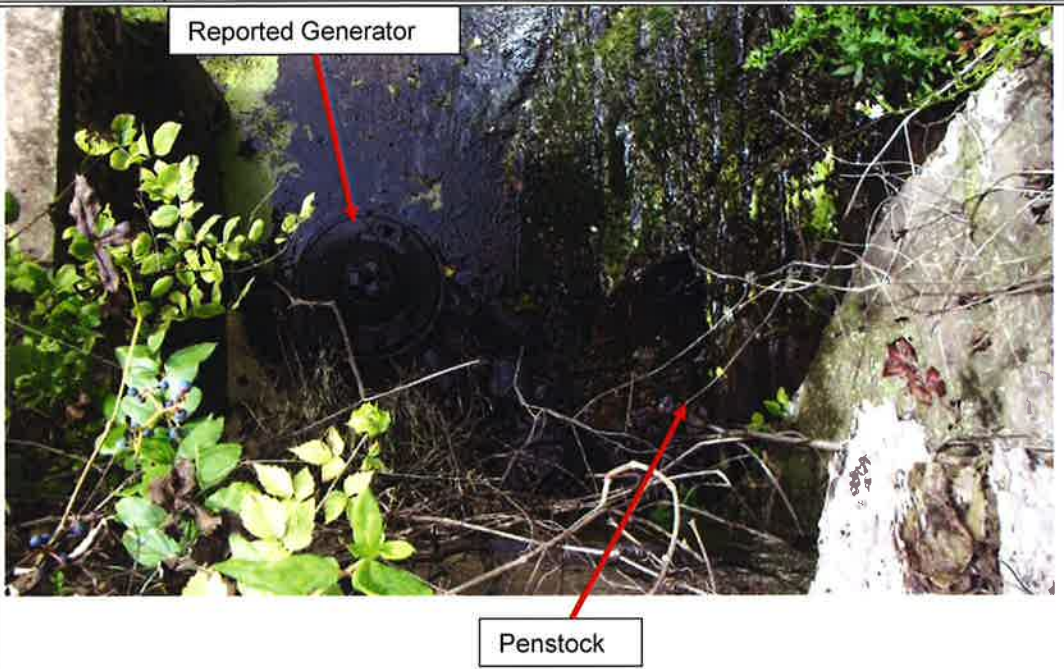
General Condition: Poor - The end pipe appeared to be uneven on the end indicating possible corrosion or rusting. Due to flowing water over the dam, the outlet structure could only be observed from the top of the dam, which limited our ability to assess its size or condition.

Description:
Looking down from spillway abutment at the former turbine housing structure. Note the pipe (penstock) on the right.

- f. Perform a pipe inspection of the 15-inch pipe that passes through the dam.
 - g. Investigate the condition and operability of the intake structure and shut off gate valve. Use of divers or ROV's is anticipated.

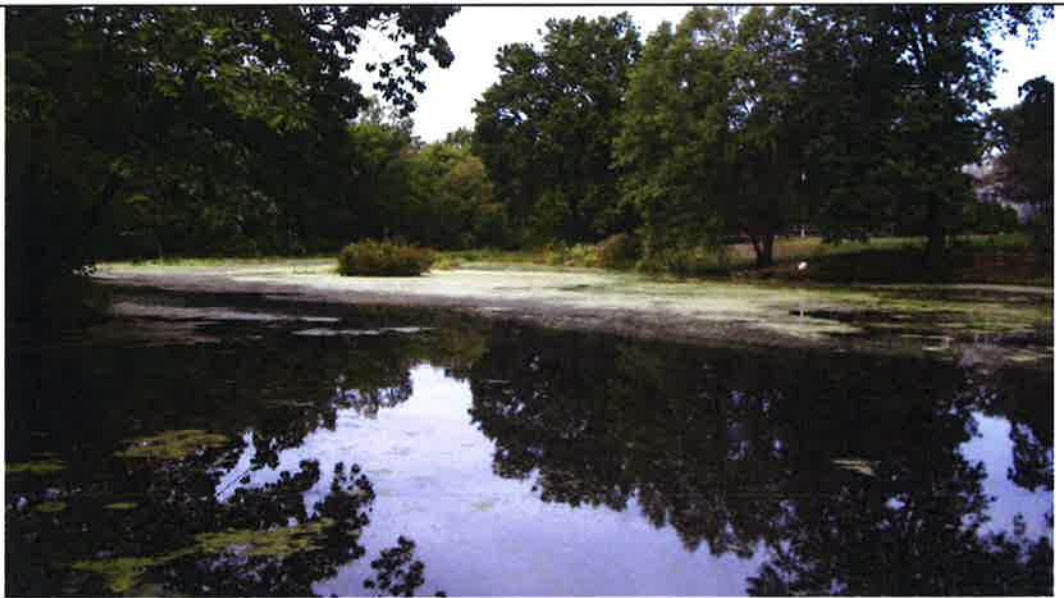
Description:
Overview of reservoir area.

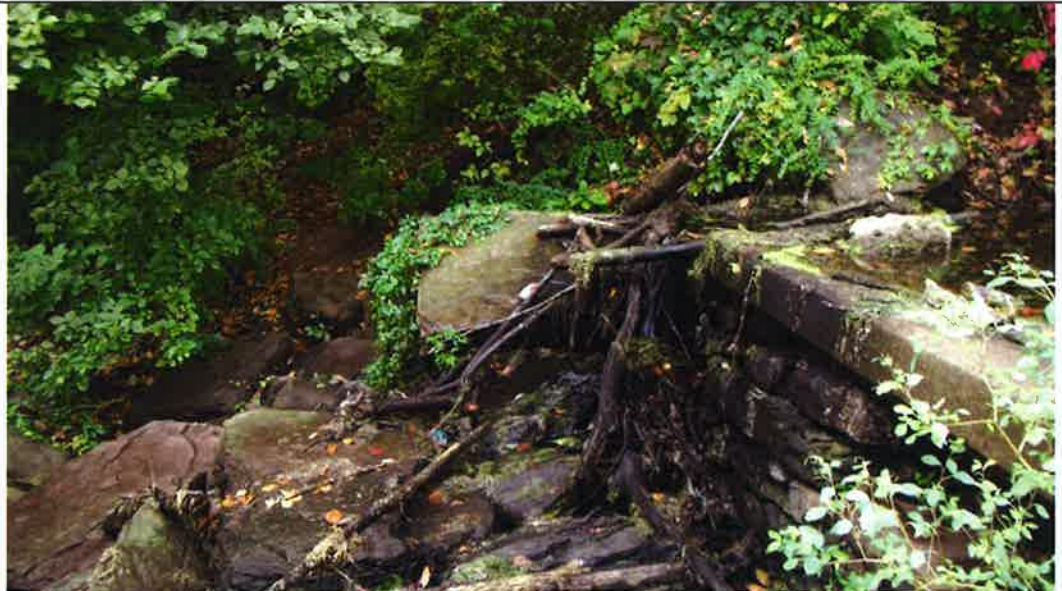
Settlement/Alignment/Movement: The concrete cap on the auxiliary spillway crest has settled where it ties into the right abutment. The settlement is approximately 3-inches over a 5-foot section. Several masonry stones below this cap were displaced or missing (upstream to downstream). Water was observed flowing over the auxiliary spillway in the area where the cap was missing.

Other: Silty sediment appears to extend up the top of the auxiliary spillway within the impoundment. The upstream portion of the auxiliary spillway concrete cap was submerged and could not be observed. Woody debris was observed in the depression where the cap had settled.

Description:
Overview of water overtopping auxiliary dam. The capstone in this section has settled due to missing masonry stone. Woody debris has collected in this area.

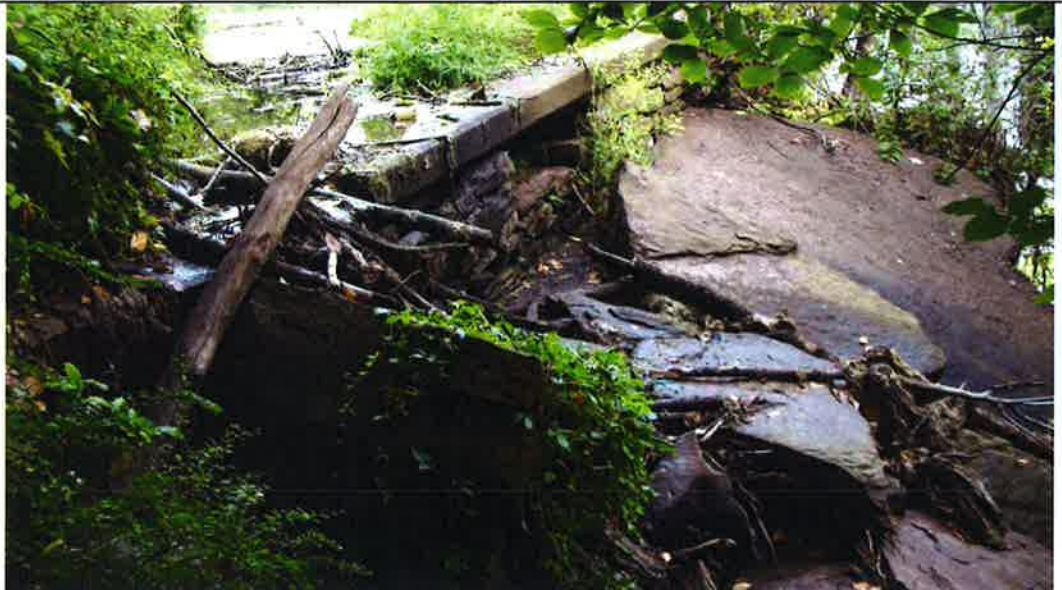
Cracks: The concrete cap near the abutment contact was cracked where the cap had settled.

Description:
Overview of auxiliary spillway showing settled capstone and woody debris.

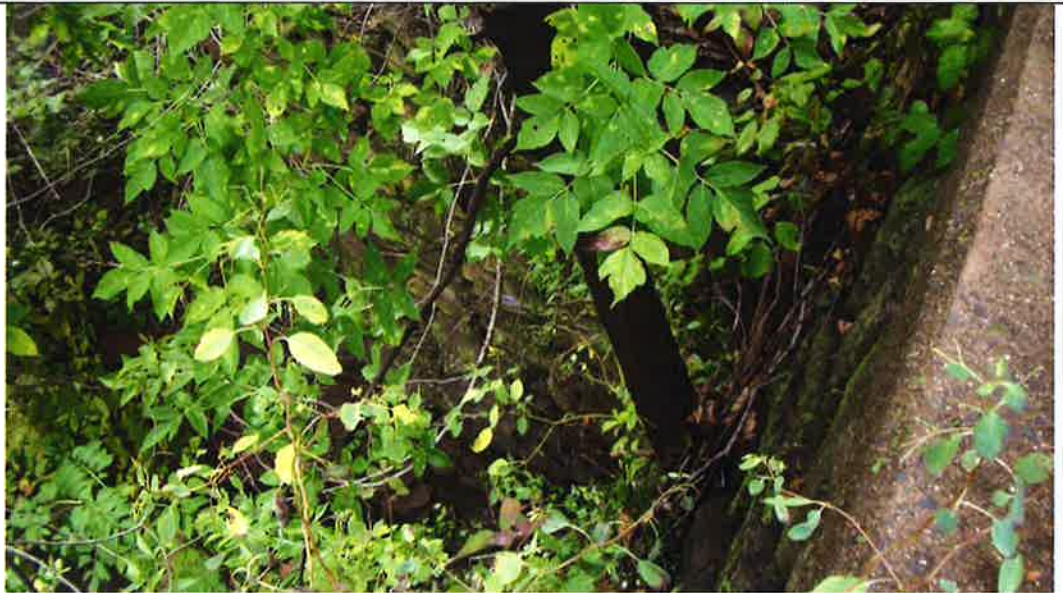
Description:
Overview of downstream side of dam at the abutment of the perpendicular masonry wall and the auxiliary spillway. Note the tree growing out of the masonry wall which is perpendicular to the auxiliary spillway.

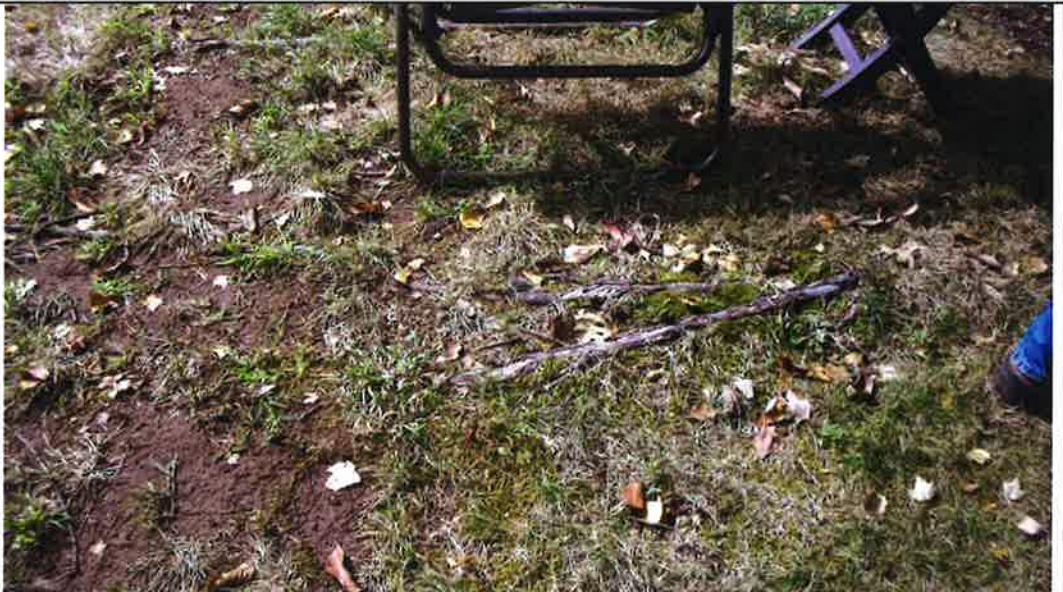
Other: Tree roots at the surface were observed on the crest of the dam.

Description:
Tree roots observed in the crest of the dike.

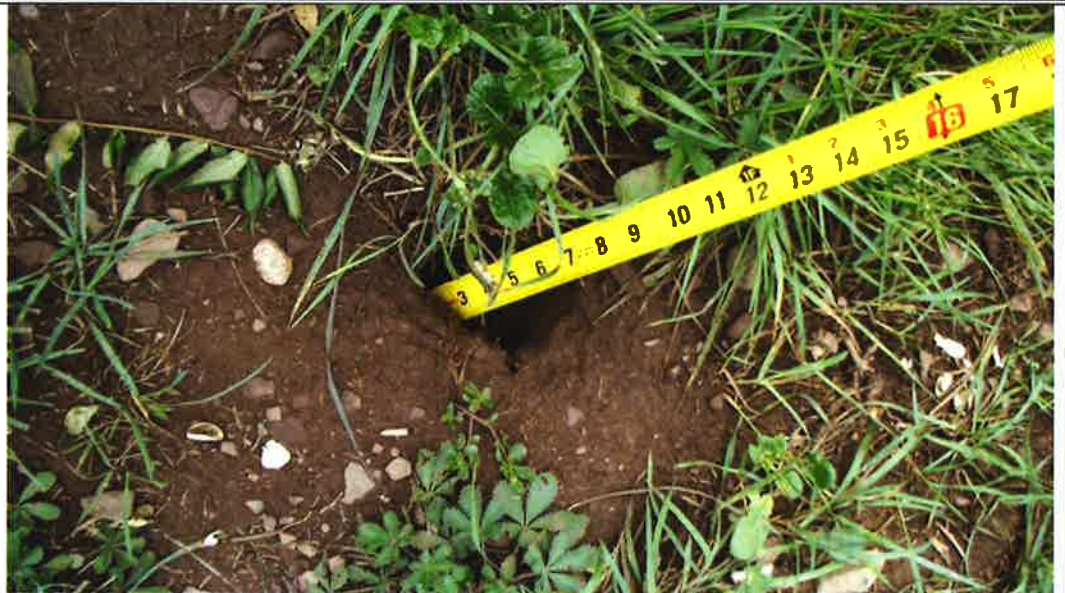
Erosion/Burrows: Several animal burrows measuring 3-inches in diameter and up to 6-inches deep were observed on the upstream slope. Erosion was observed on the crest, upstream and downstream slope at the dike contact with the former turbine housing structure.

One of a cluster of animal burrow holes located in the crest of the dike.

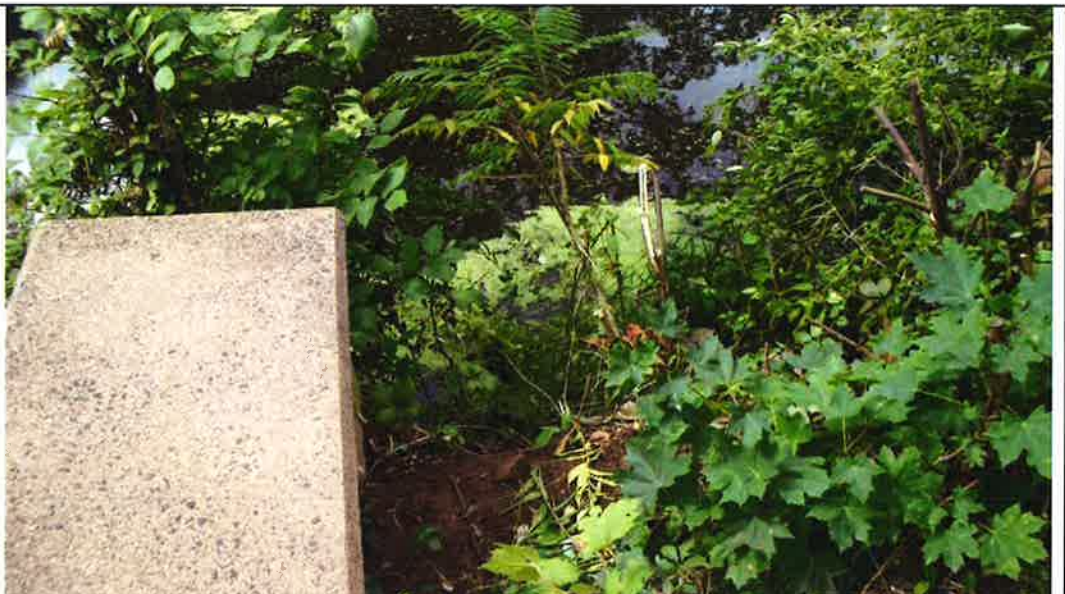
Surface erosion on the upstream side of the dike at the spillway contact.

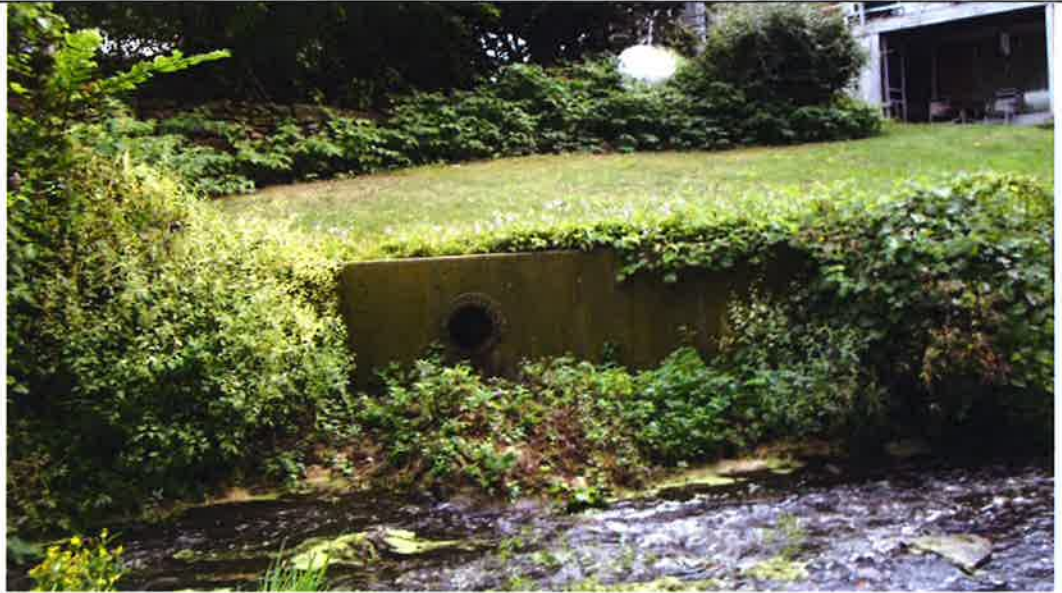
Description:
Storm drain outlet pipe in retaining wall of downstream channel.
