**– 1860 RESERVOIR DAM –**  
**VISUAL INSPECTION REPORT**

Dam Name: 1860 Reservoir Dam

Date of Inspection: September 27, 2016

Re: Visual Inspection Report  
1860 Reservoir  
CTDEEP # 15908

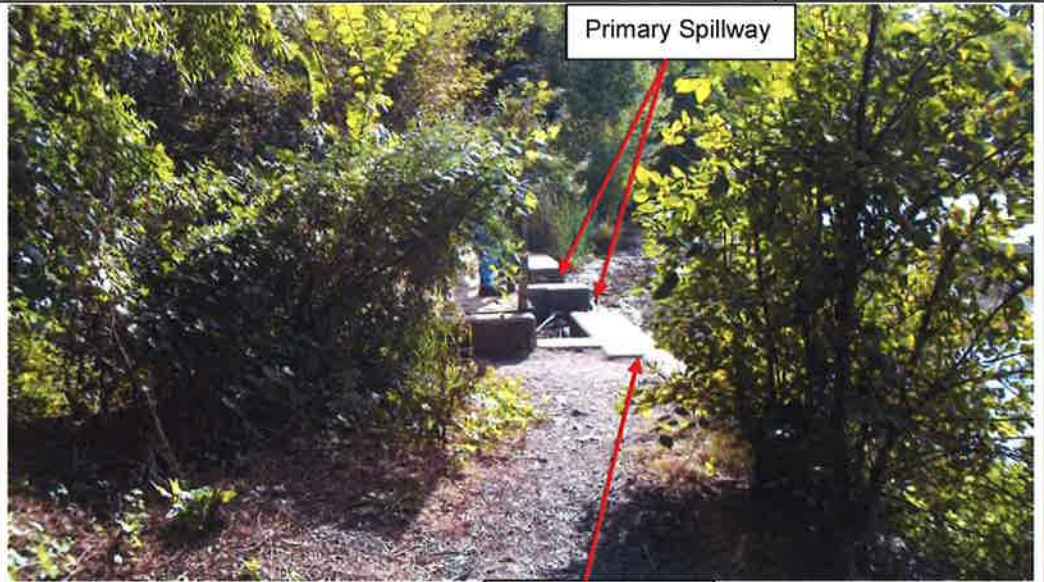
Photo No.: 04 Date: 9/27/16

Overview of the upstream slope of the right embankment looking towards the right abutment from the primary spillway.

Note thick vegetation, brush and mature trees on the right embankment.

1. Remove trees greater than 3-inch diameter, including root balls, on the left embankment and right embankment (crest and upstream and downstream slopes). Coordination with the CT DEEP and the local conservation commission should be performed to establish an appropriate lateral limit for the tree removal downstream of the dam. This coordination should consider the hazard class of the dam, the extents of the wetlands, and if seepage conditions are observed once the trees are removed from the downstream slope. Fill, compact, seed and maintain grass upon completion.
2. Downstream of the auxiliary spillway, install an appropriate erosion mitigation measure (i.e. reinforced turf, riprap or concrete on portions of the right and left embankments that are downstream of the auxiliary spillway. The intent would be to mitigate the potential for auxiliary flows to cause erosion of the embankments.

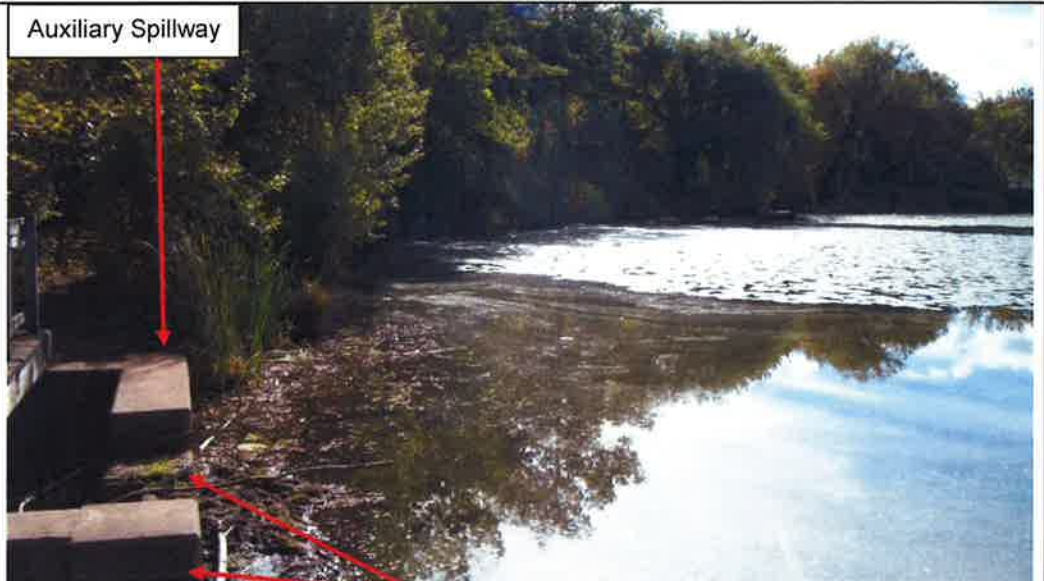
Overview of the right embankment crest, upstream slope and downstream slope looking towards the right abutment from the auxiliary spillway.

Note thick vegetation, brush and mature trees. The right embankment crest is depressed from use as a walking path.

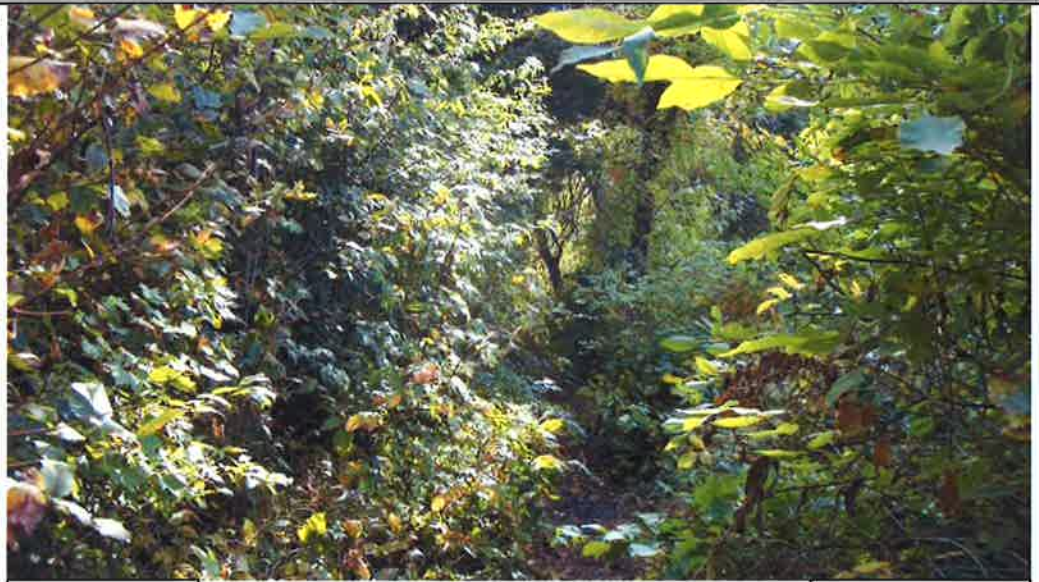
Overview of the upstream slope of the right embankment looking towards the right abutment from the upstream slope of the right embankment.

Note thick vegetation, brush and mature trees.

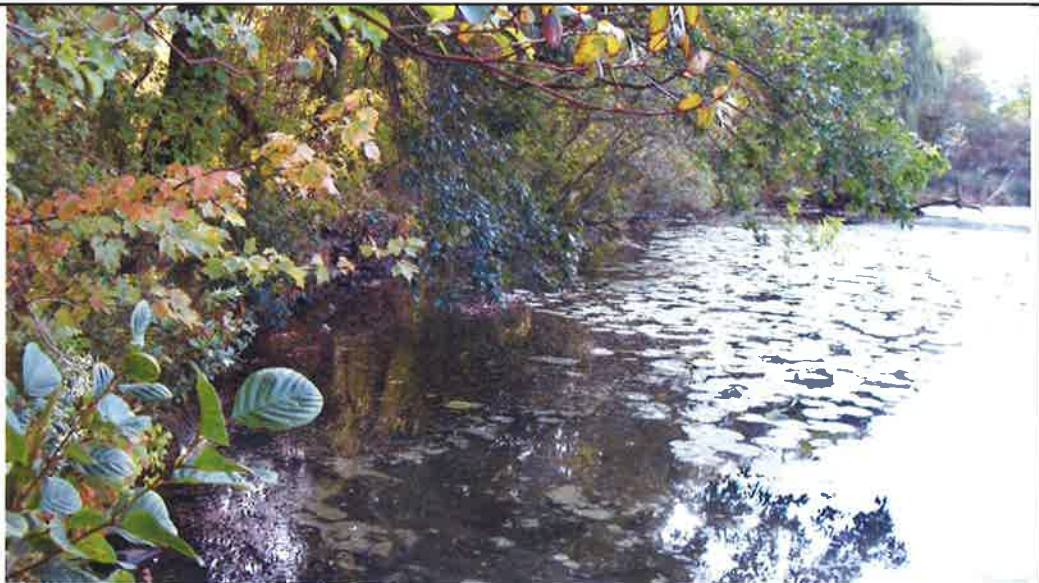
Overview of the upstream slope of the right embankment looking towards the primary spillway from the upstream slope of the right embankment.

Note the thick brush and mature trees on the upstream slope and crest.

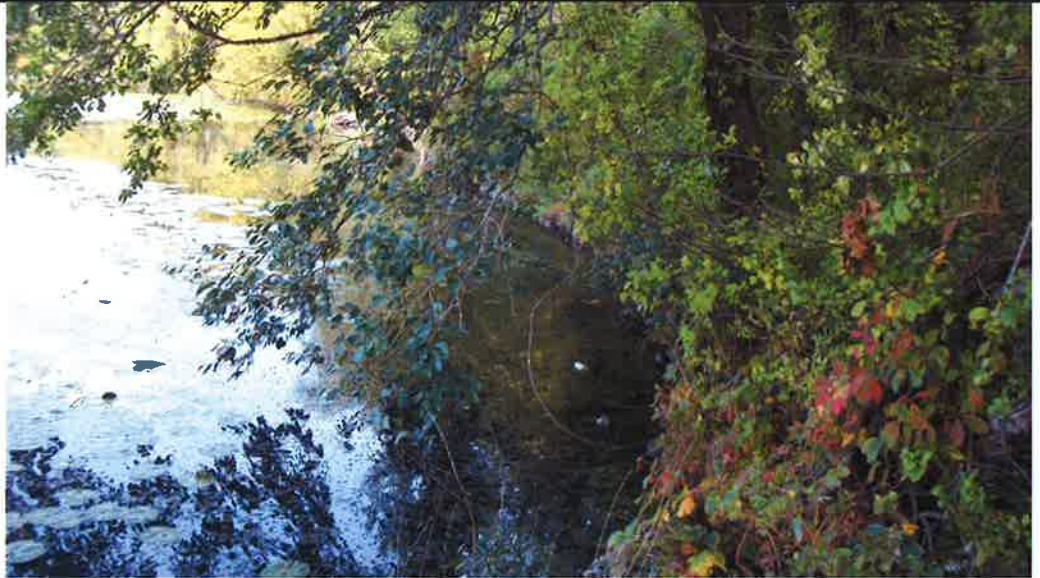
**Photo No.:**  
08

Overview of the upstream slope and crest of the left embankment looking towards the left abutment from the auxiliary spillway.

Note the thick brush and mature trees on the upstream slope and crest.

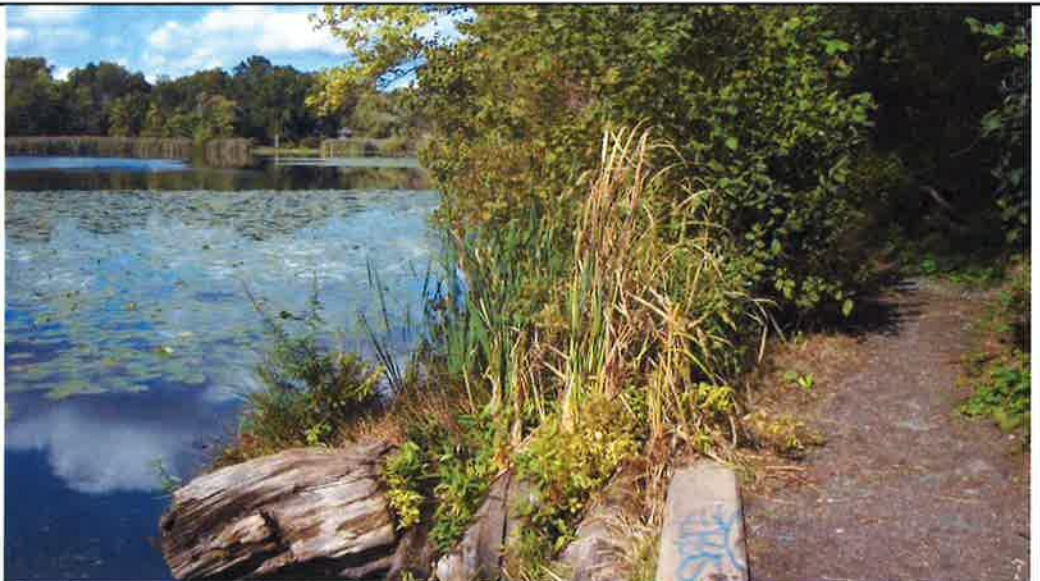
Overview of the left embankment crest looking from the spillway towards the left abutment.

Note the thick brush.

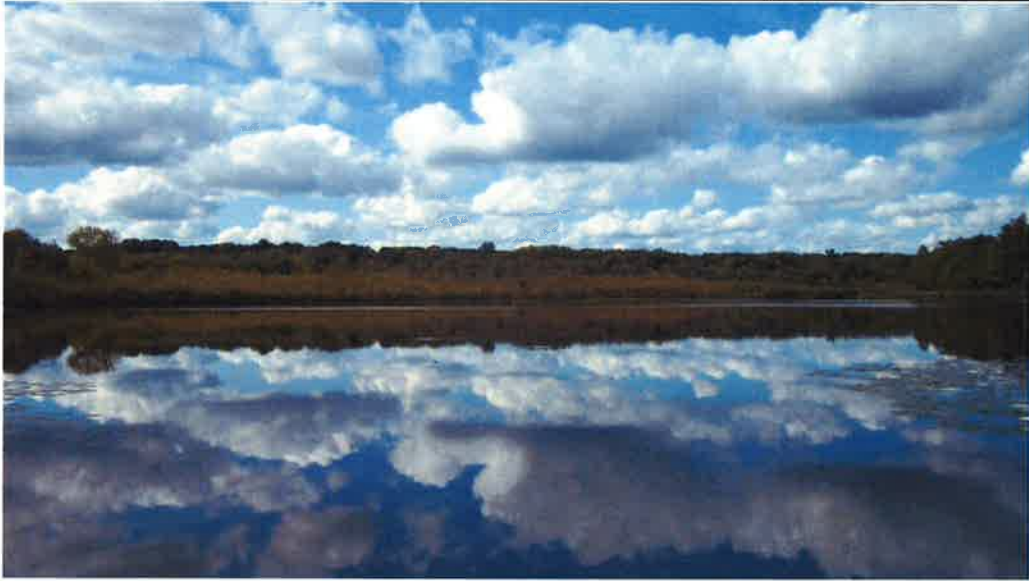
<b>Direction Photo Taken:</b> Northwesterly		
<b>Photographer:</b> D. Barstow		
<b>Description:</b>  Overview of reservoir area looking upstream from the timber bridge over the spillways.

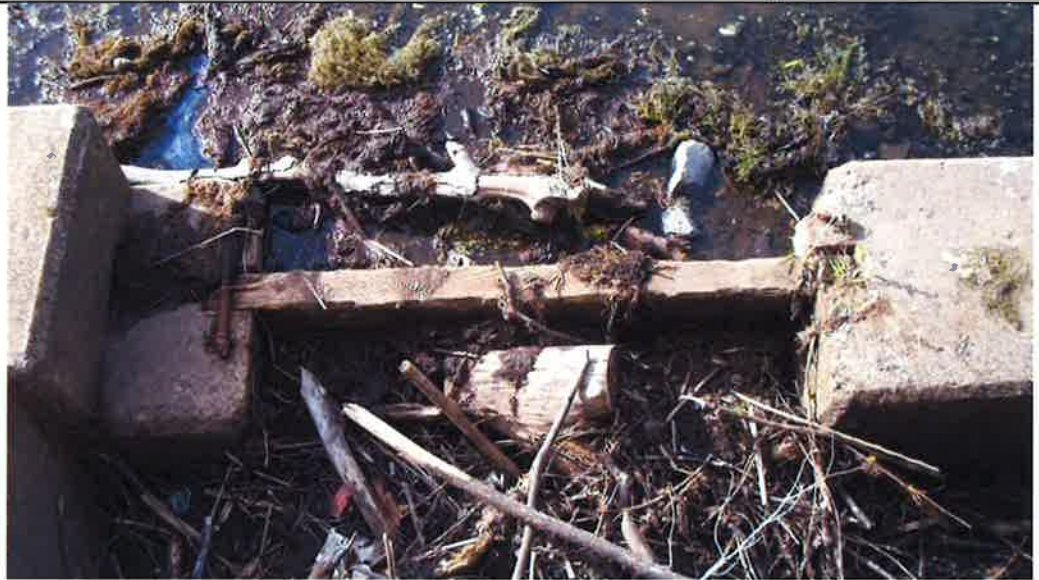
**Photo No.:** 14  
**Date:** 9/27/16

Overview of downstream channel looking downstream from the timber bridge. Note the sticks and logs in the downstream channel.
