– *SPRING STREET POND DAM* –  
VISUAL INSPECTION REPORT

Dam Name: Spring Street Pond Dam

Date of Inspection: September 27, 2016

Re: Visual Inspection Report  
Spring Street Pond Dam  
CTDEEP # 15911

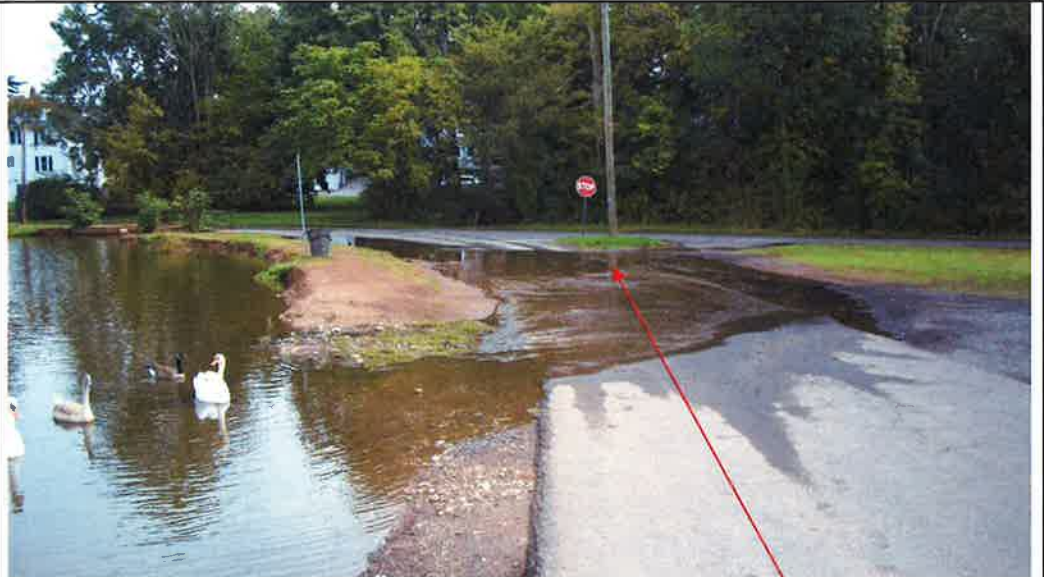
Photo No.: 04 Date: 9/27/16

Description: Overview of the left embankment from left abutment. Note bare areas and areas of erosion at the upstream slope and crest near the sign post.

Area of Erosion

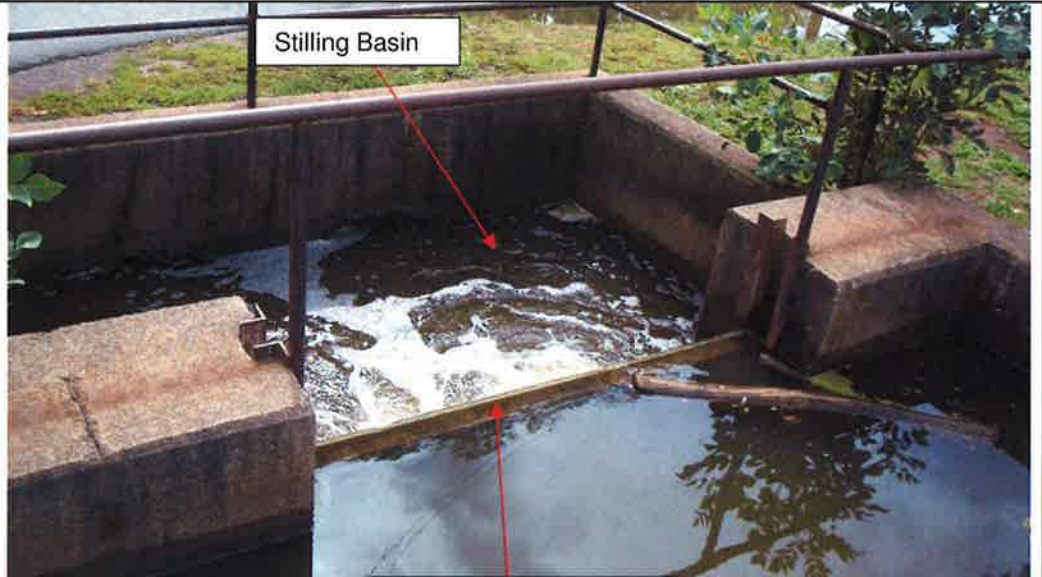
Photo No.:  
06

Overview of spillway from upstream. Note timber stop logs in spillway and log on right side of spillway.

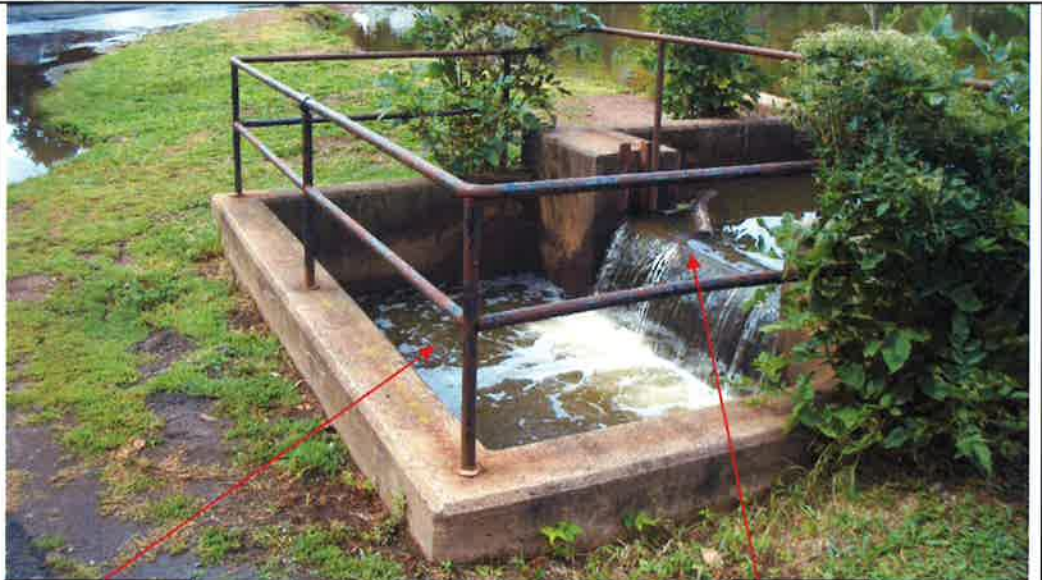
Overview of spillway from downstream. Note brush on either side of spillway.

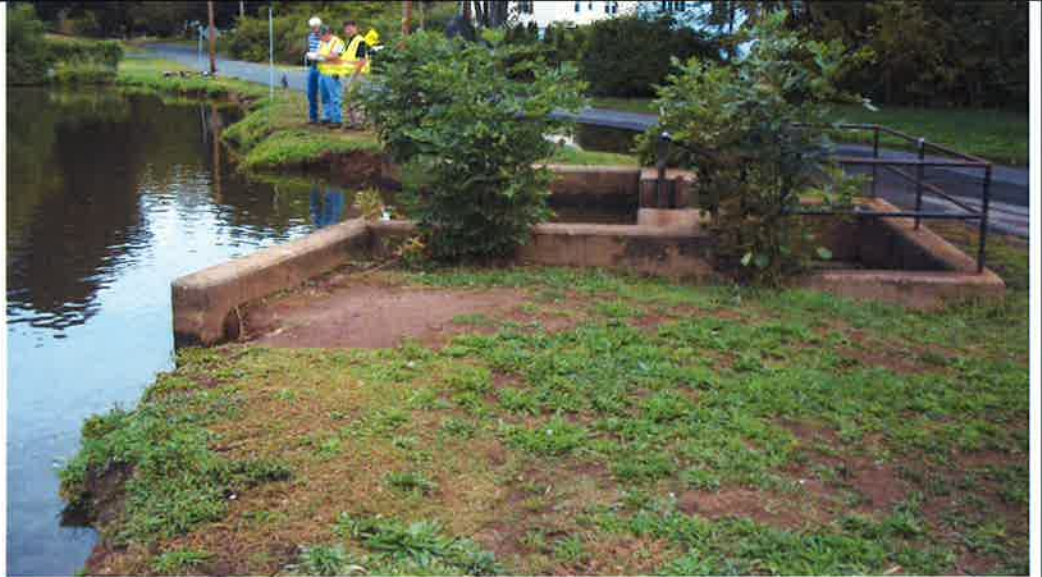
08

Overview of right training wall. Note areas of erosion at contact with embankment.

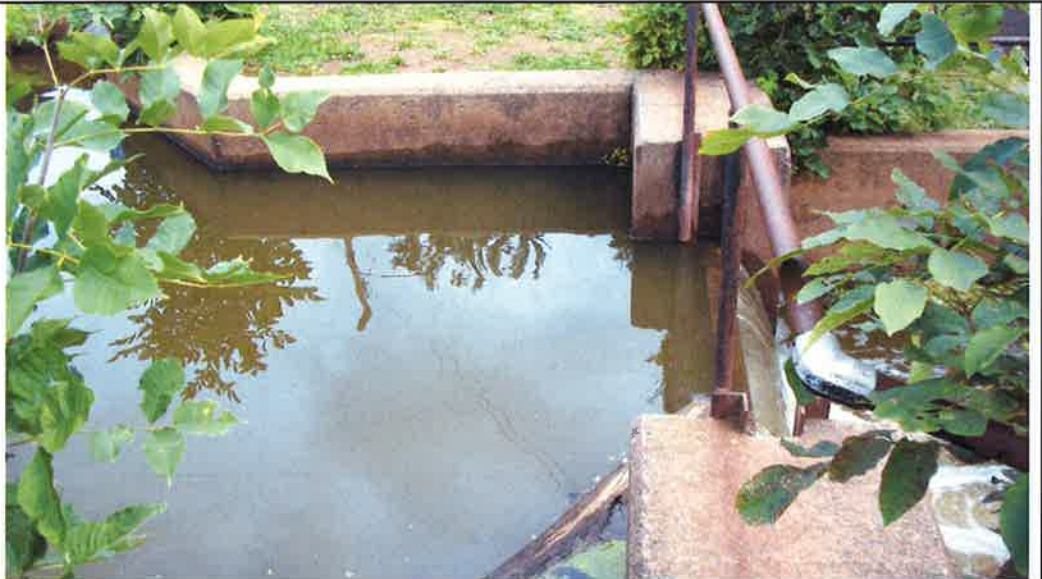
Overview of left training wall and spillway.

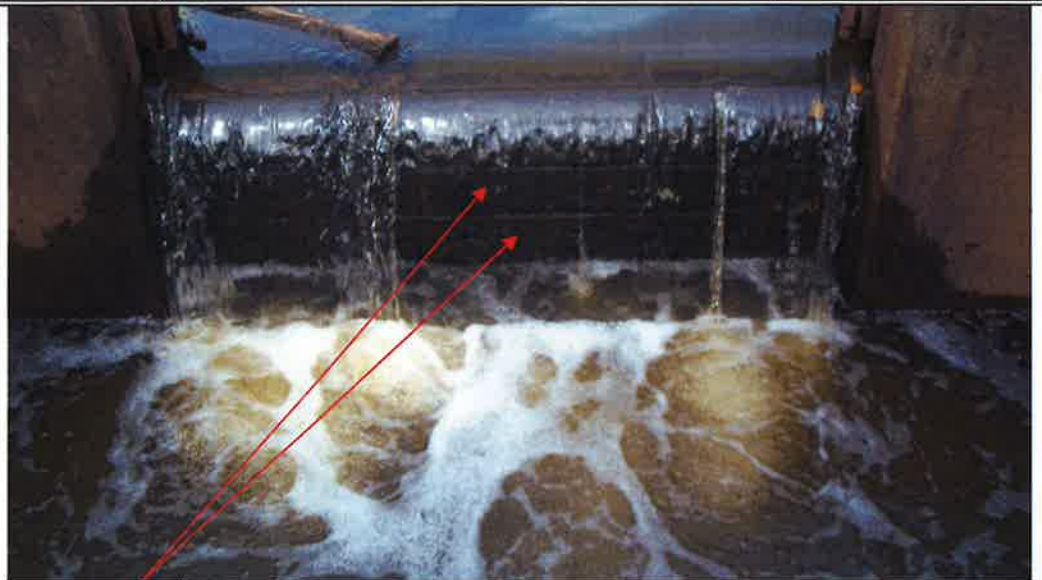
Photo No.: 10  
Date: 9/27/16

Overview of broad crested weir. Note stop logs.

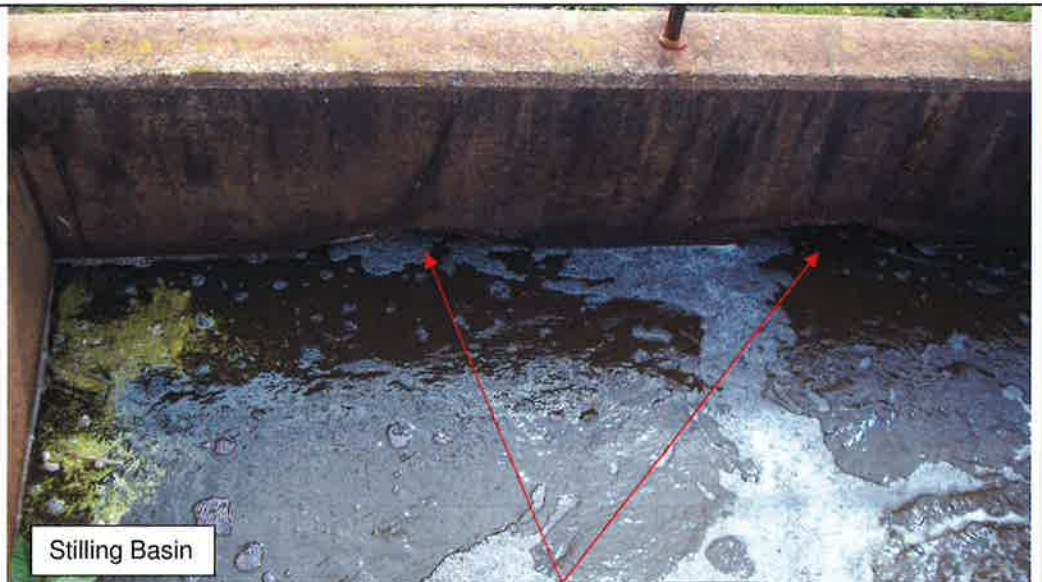
Overview of stilling basin. Note the tops of the two 36-inch-diameter RCP outlet pipes on the downstream headwall of the stilling basin.

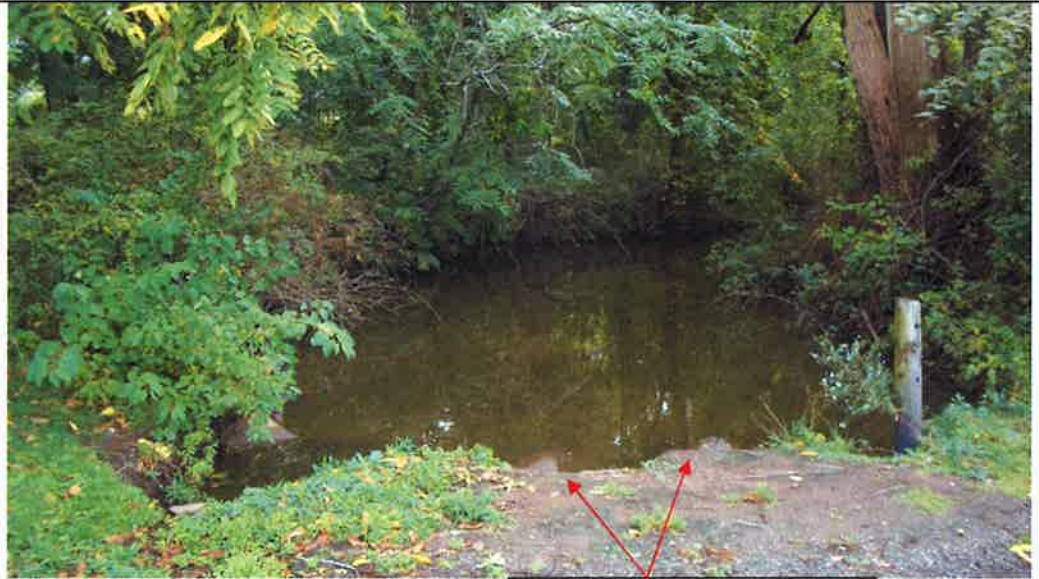
**Photo No.:**  
12

Overview of downstream channel. Note the two outlet pipes for the dam in the center of the photo. Note the lack of flow due to a possible downstream blockage.

1. Temporarily place and compact granular fill followed by loam and seed within the breached section of the right embankment to mitigate overtopping onto Spring Street during minor storm events. Permanent repairs should be performed based on the results of the previously recommended studies.
2. Continue to cut the grass on the top, downstream slope, and downstream area of the dam. Reseed as needed.
3. Remove the brush around the spillway.
4. Investigate the cause of the backwater condition in Beaver Brook downstream of the dam. Perform the necessary maintenance to remove blockages and restore flow.

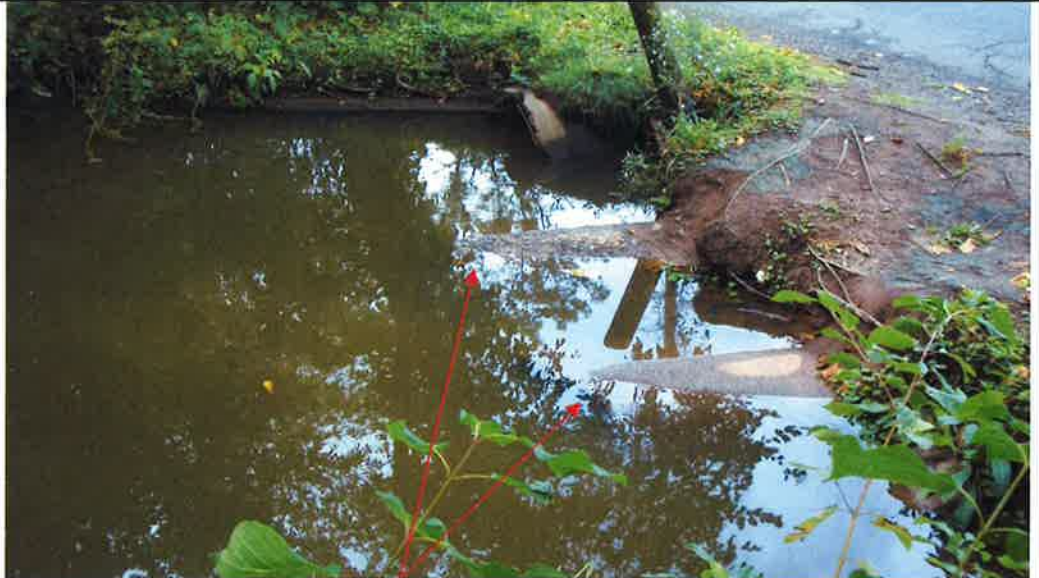
Overview of the discharge ends of the 36-inch diameter RCP outlet pipes.

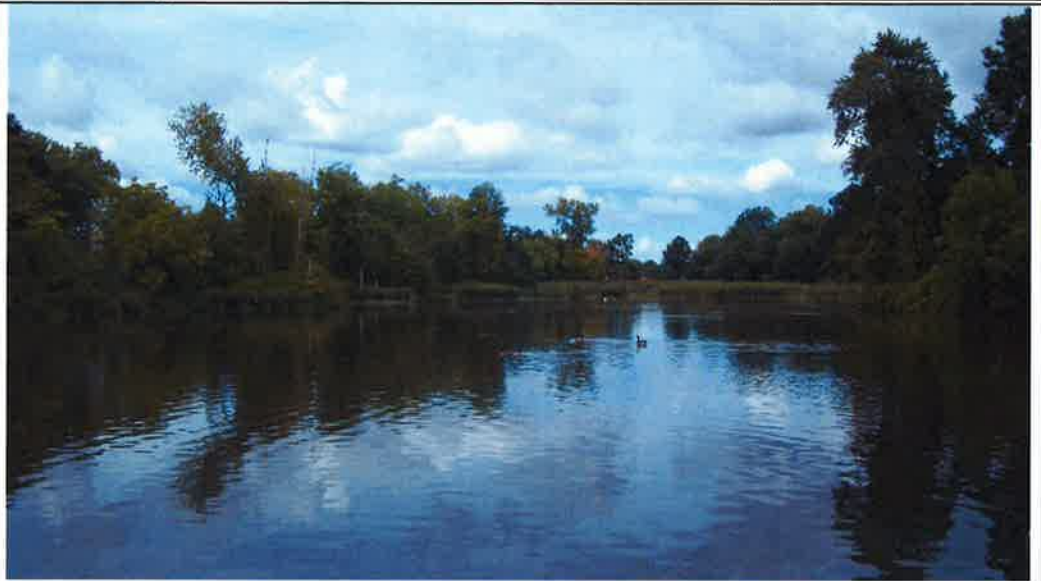
**Photo No.:**  
14

Overview of reservoir area.

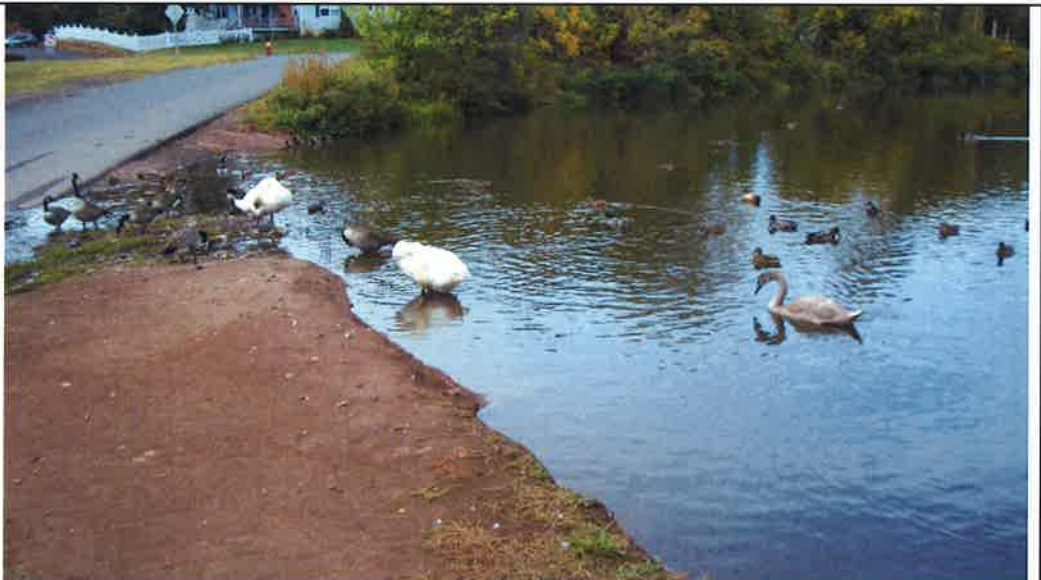
**Erosion/Burrows:** The right embankment has been eroded area over a 60-foot long section near the right abutment. At the time of the inspection, water was observed flowing through the eroded area and there was a 20-foot wide channel with 2 to 3 inches. The water flowed across the Spring Street to a stormwater catch basin in Spring Street East. The catch basin outlet discharges to Beaver Brook. The upstream slope of the embankment was undercut and a 1- to 1.5-foot high, vertical soil slope was observed at the water's edge. Rutting/displaced soil apparently due to vehicular traffic was observed on the downstream slope.

Right embankment breach near the right abutment contact. Note the bare soil on the crest of the right embankment.

1. Perform preliminary studies to evaluate permanently repair options for the breach in the right embankment and to evaluate overtopping protection options for the dam. The studies should include a limited hydrologic and hydraulic (H&H) study to determine reservoir elevations for various flood levels (i.e. 10-year, 50-year and 100-year). Determine the depths of overtopping over the embankments for each flood. Evaluate overtopping protection options (i.e. loam and seed, reinforced turf mat, and riprap) to protect the embankment from erosion during overtopping events. Select the most appropriate option based on a balance of risk and short-term/long-term costs.
2. Inspect the condition of the spillway, stilling basin and 36-inch diameter outlet pipe when they are not submerged.

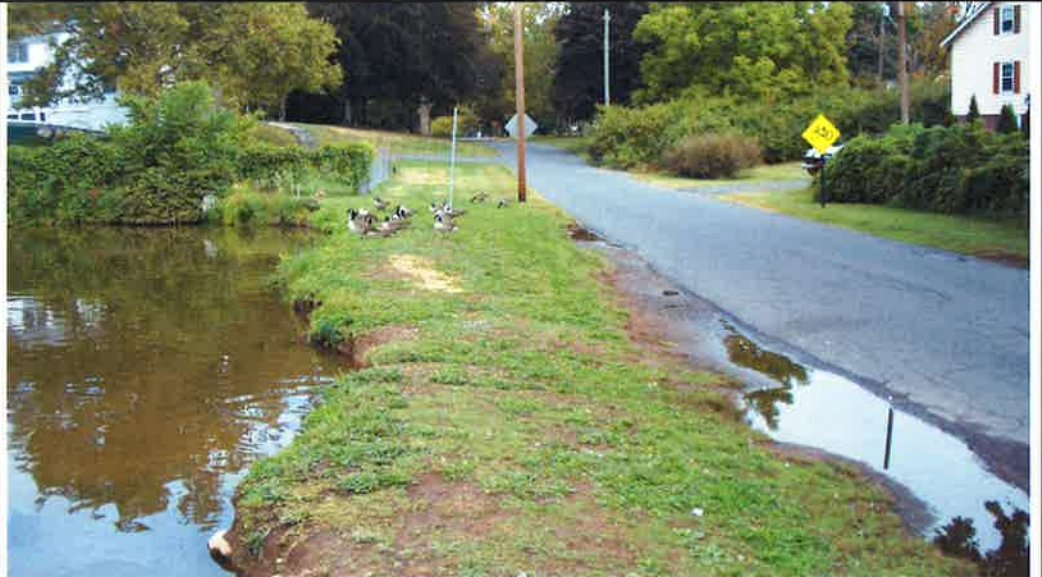
**Photo No.:**  
16

**Erosion/Burrows:** An eroded area was observed between about 55- to 90-feet from the left spillway contact. The erosion was up to 2 to 3 inches deep. The toe of the upstream embankment was undercut and a 1- to 1.5-foot high, vertical soil slope was observed at the water's edge. Rutting from vehicular traffic was observed on the downstream toe.

Pooled water at the downstream toe of the left embankment and undercutting of the upstream slope.

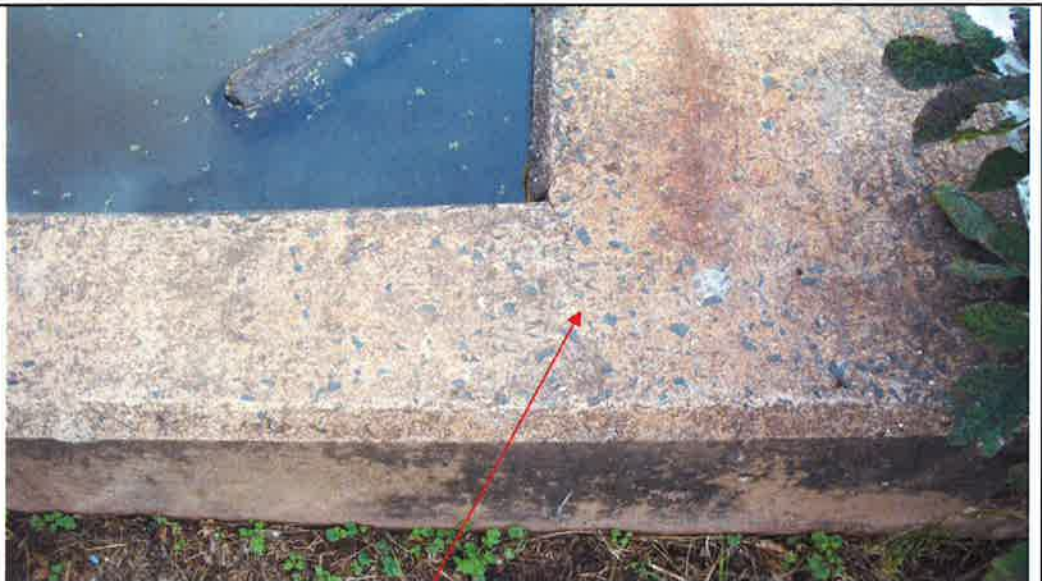
**Cracks:** A minor crack was observed on the left and right sides of the training wall at the 90-degree corner. A crack and exposed rebar were observed on the left training wall near the spillway.

Minor crack in right training wall where it intersects the spillway.

Crack
